NEPSR 2010 Pipeline Safety

Don Ledversis,
Rhode Island Division of Public Utilities
and Carriers

ARP Program 2009

Accelerated Replacement Program

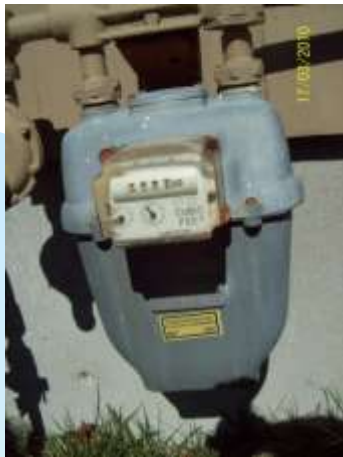
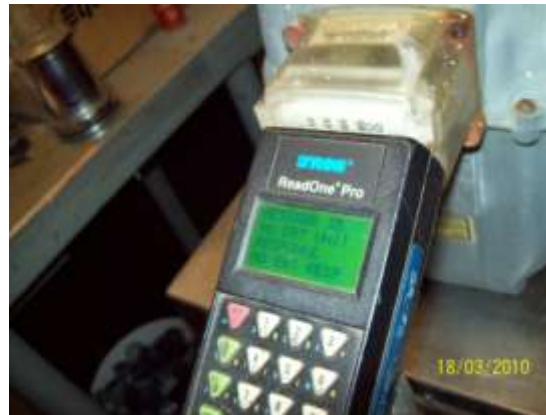
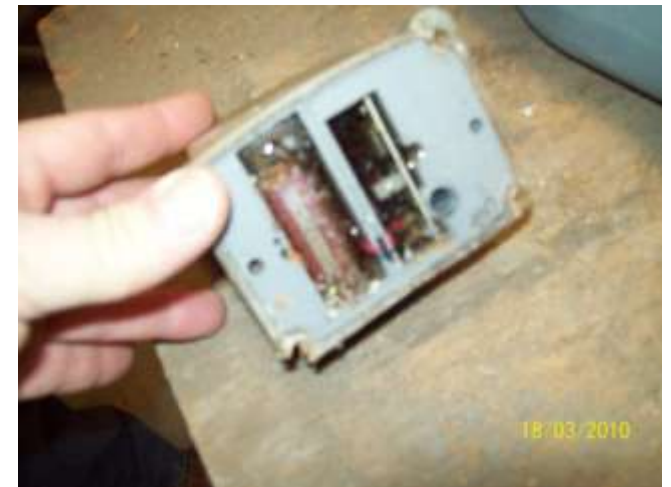
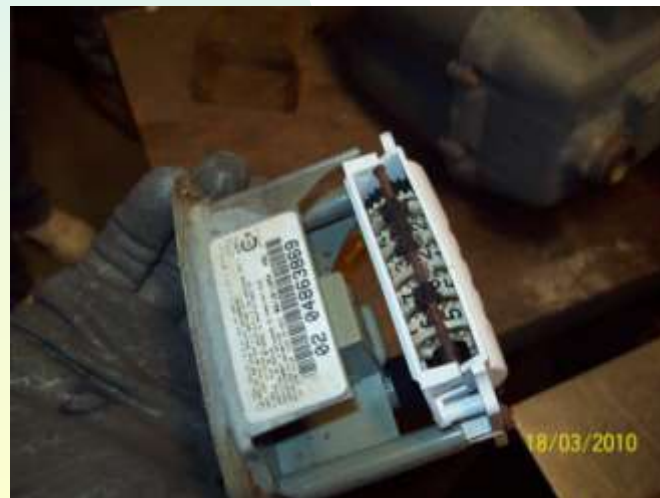
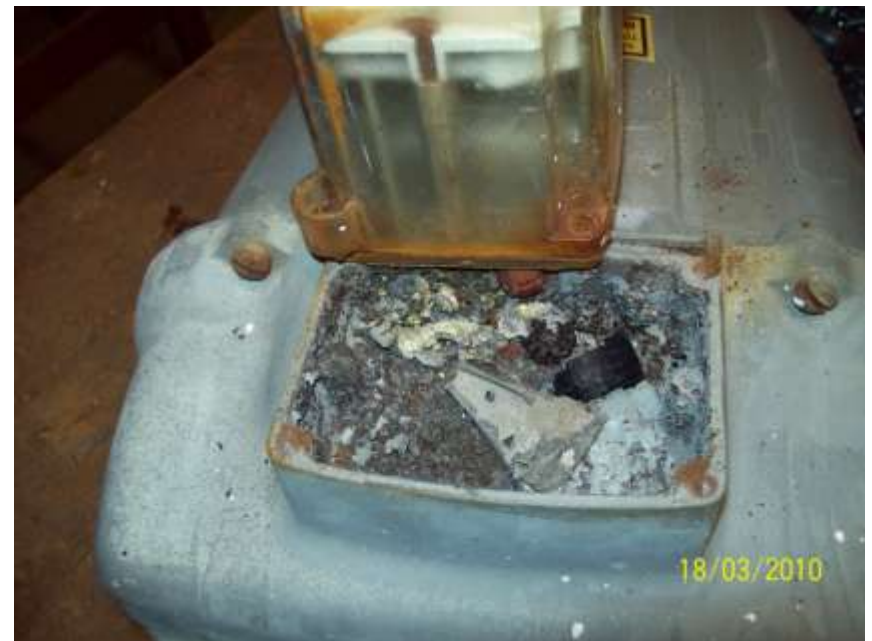
72 Wisteria

(unusual corrosion issue)

*Each meter...must be... protected from
corrosion*

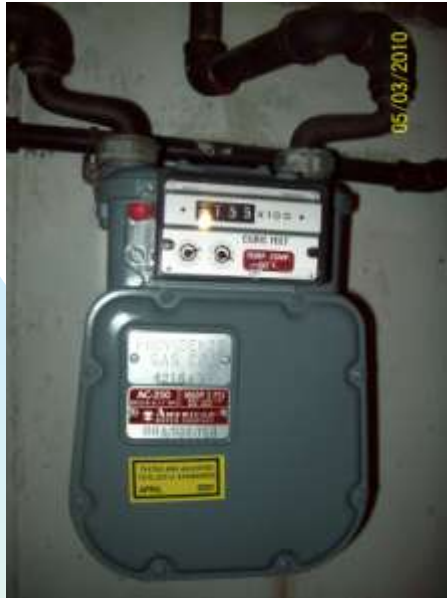
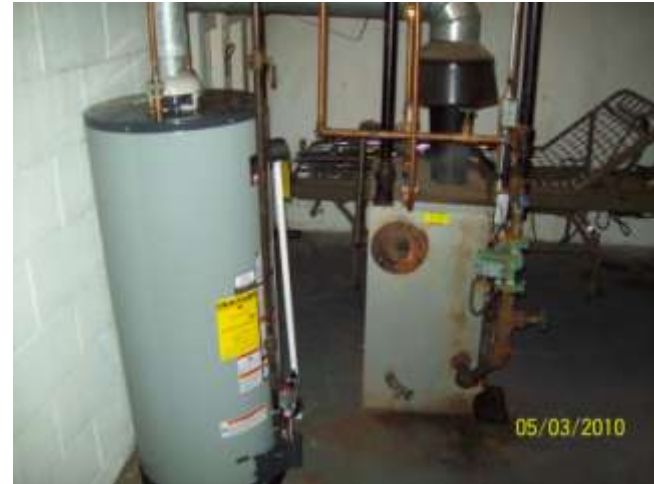
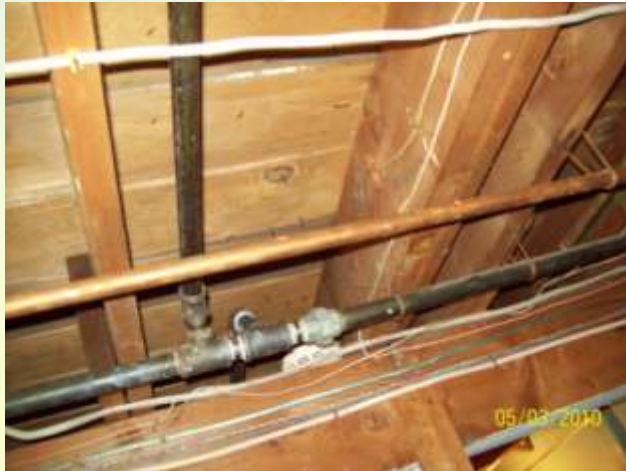
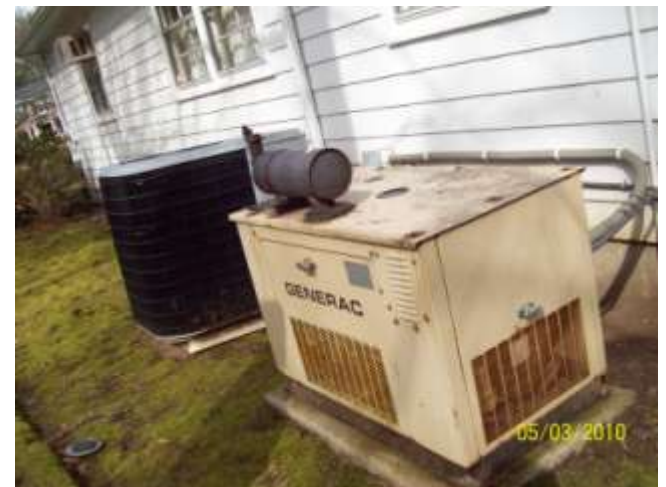
Laurel Hill

(vacuum)

(a) Protection from vacuum... If the customer's equipment might create a vacuum a device must be installed to protect the system.

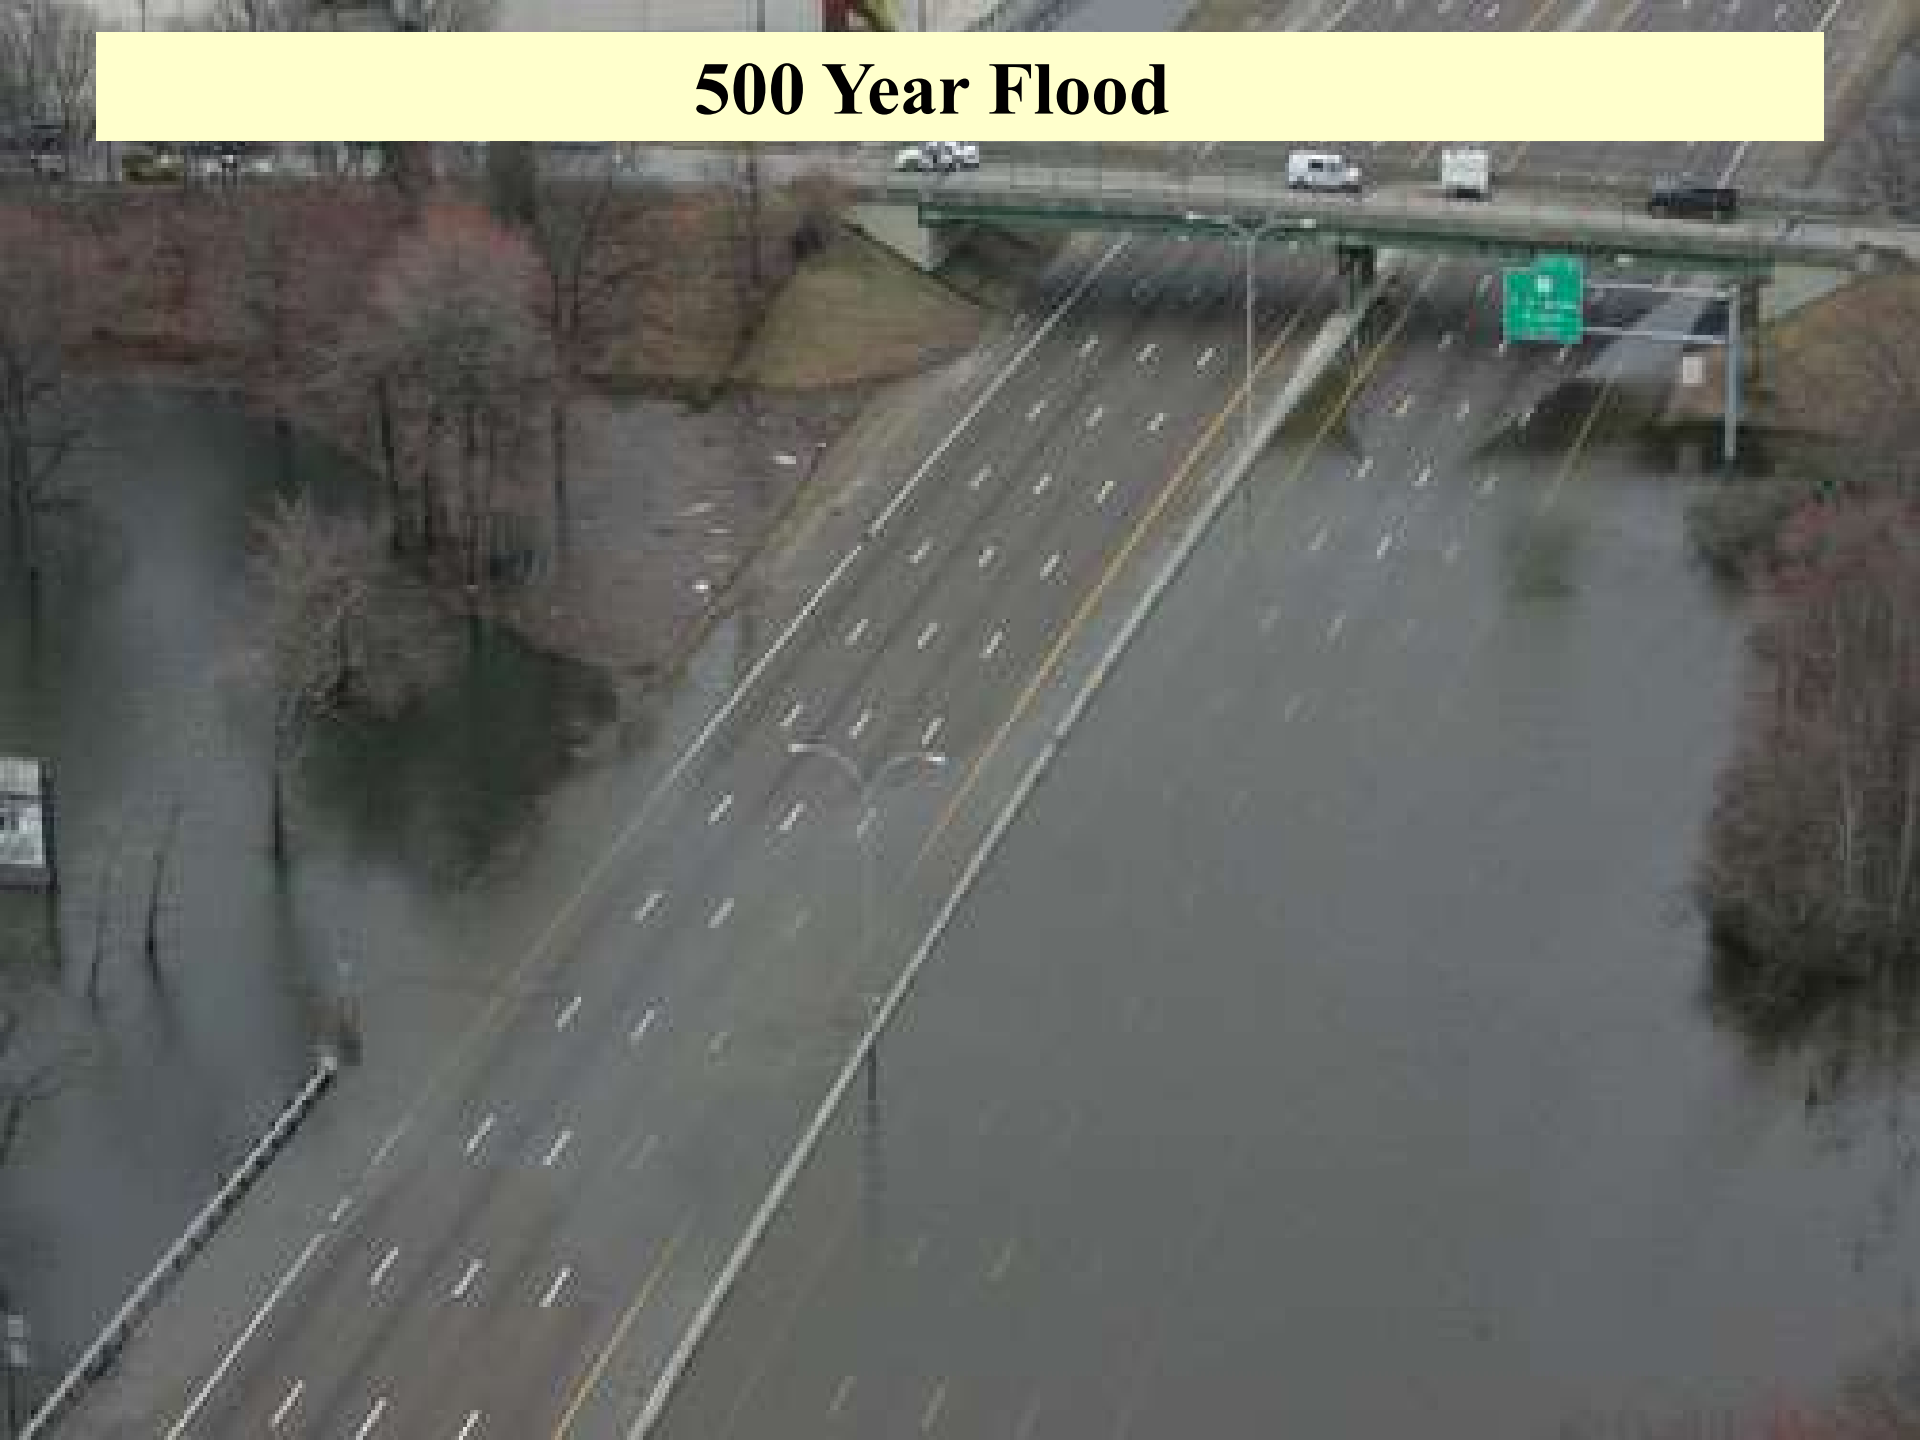
500 Year Flood

*(b)(3) Service regulator vents and relief vents...
must: Be protected from damage caused by submergence
in areas where flooding may occur.*

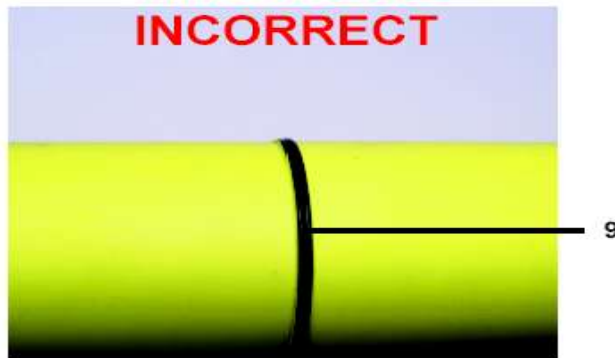
9. Insufficient heat time; melt bead too small

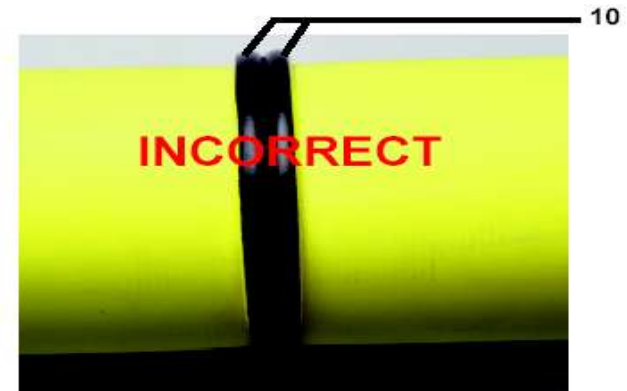
10. Excessive heat time or pressure applied during heating; melt bead too large

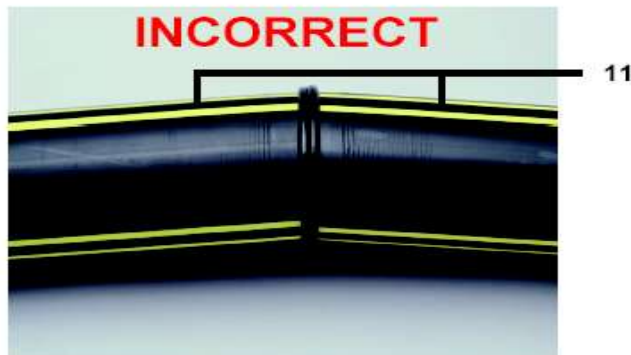
11. Pipe angled into fusion unit

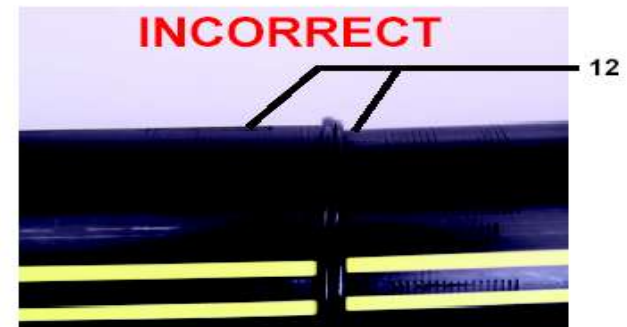
12. Improper "High-Low" alignment

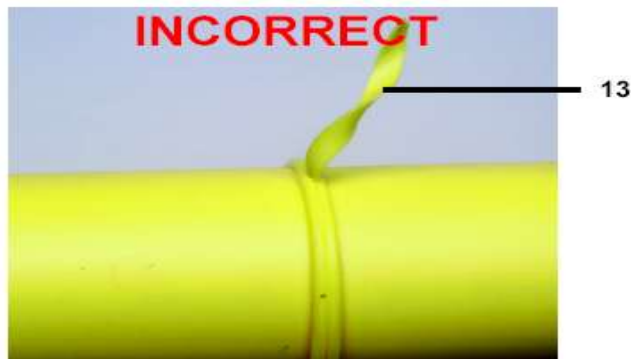
13. Incomplete face off or failure to re-

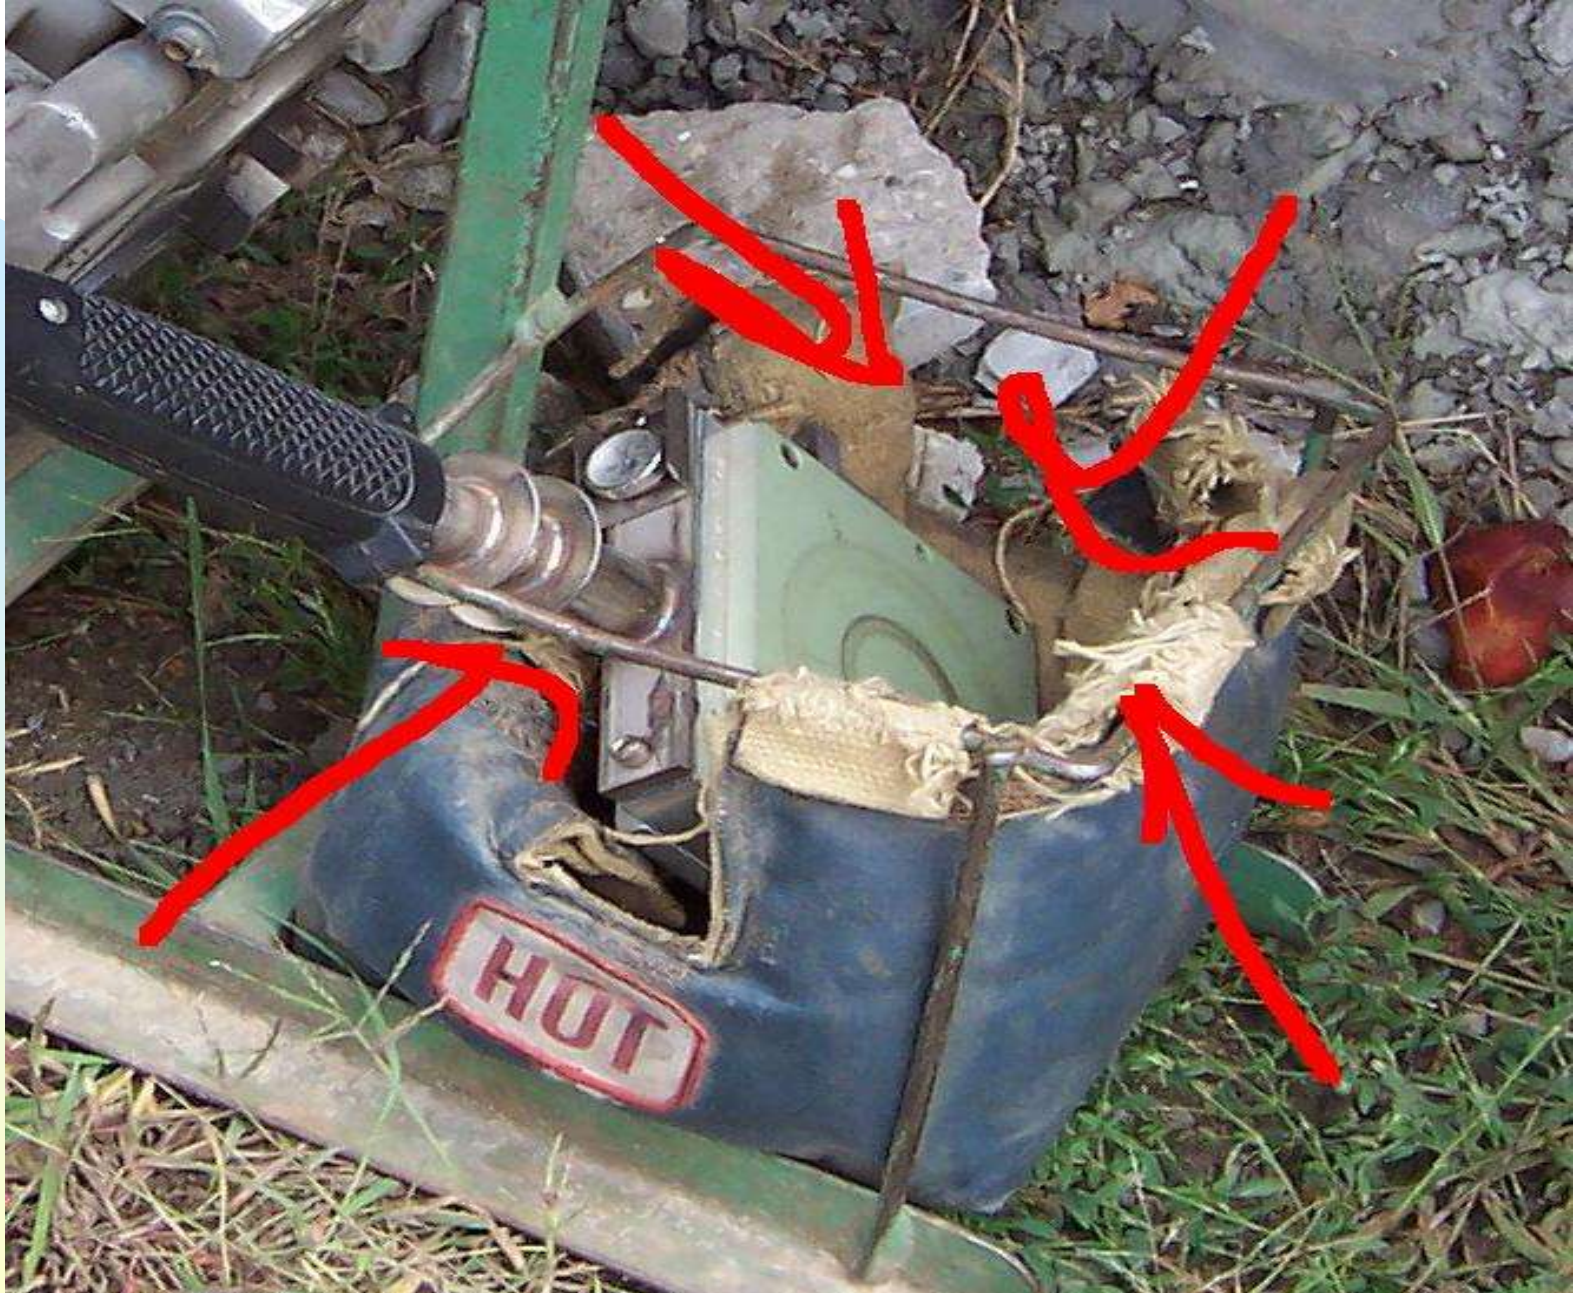
Ripped heater bag and dirty heat plate.

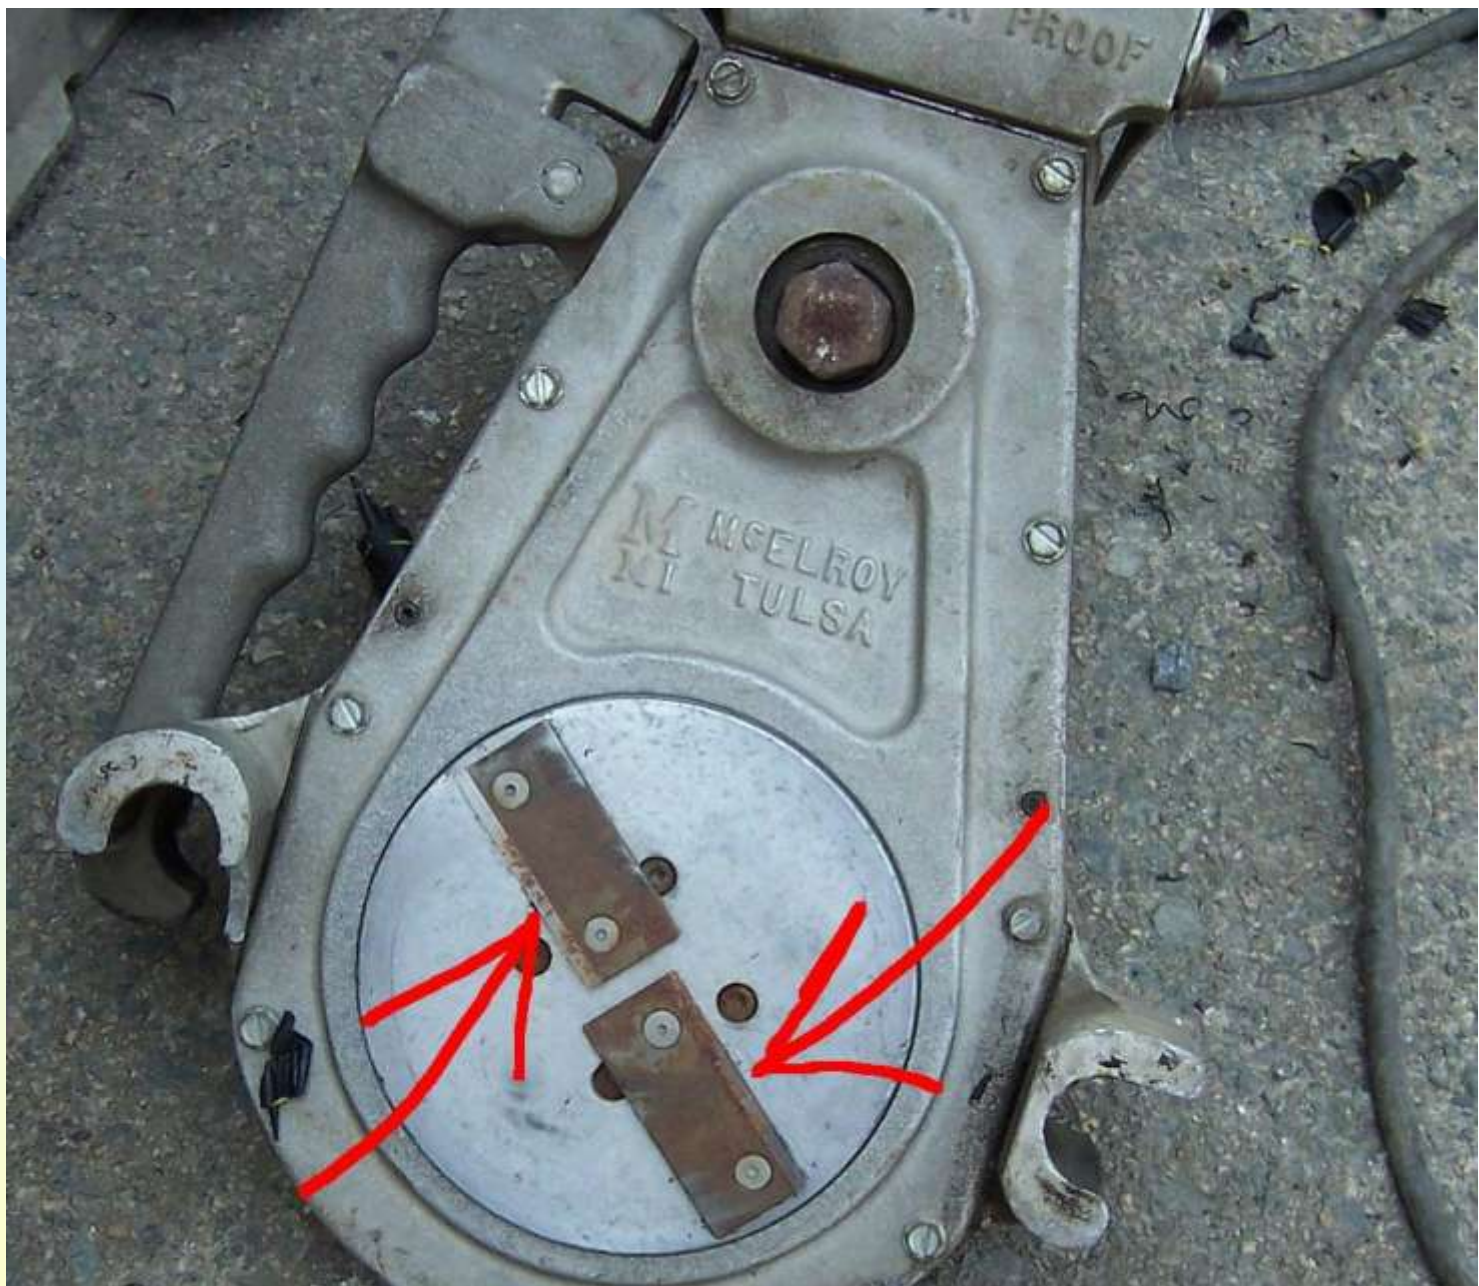
Rusty facing blades, your prone to failure.

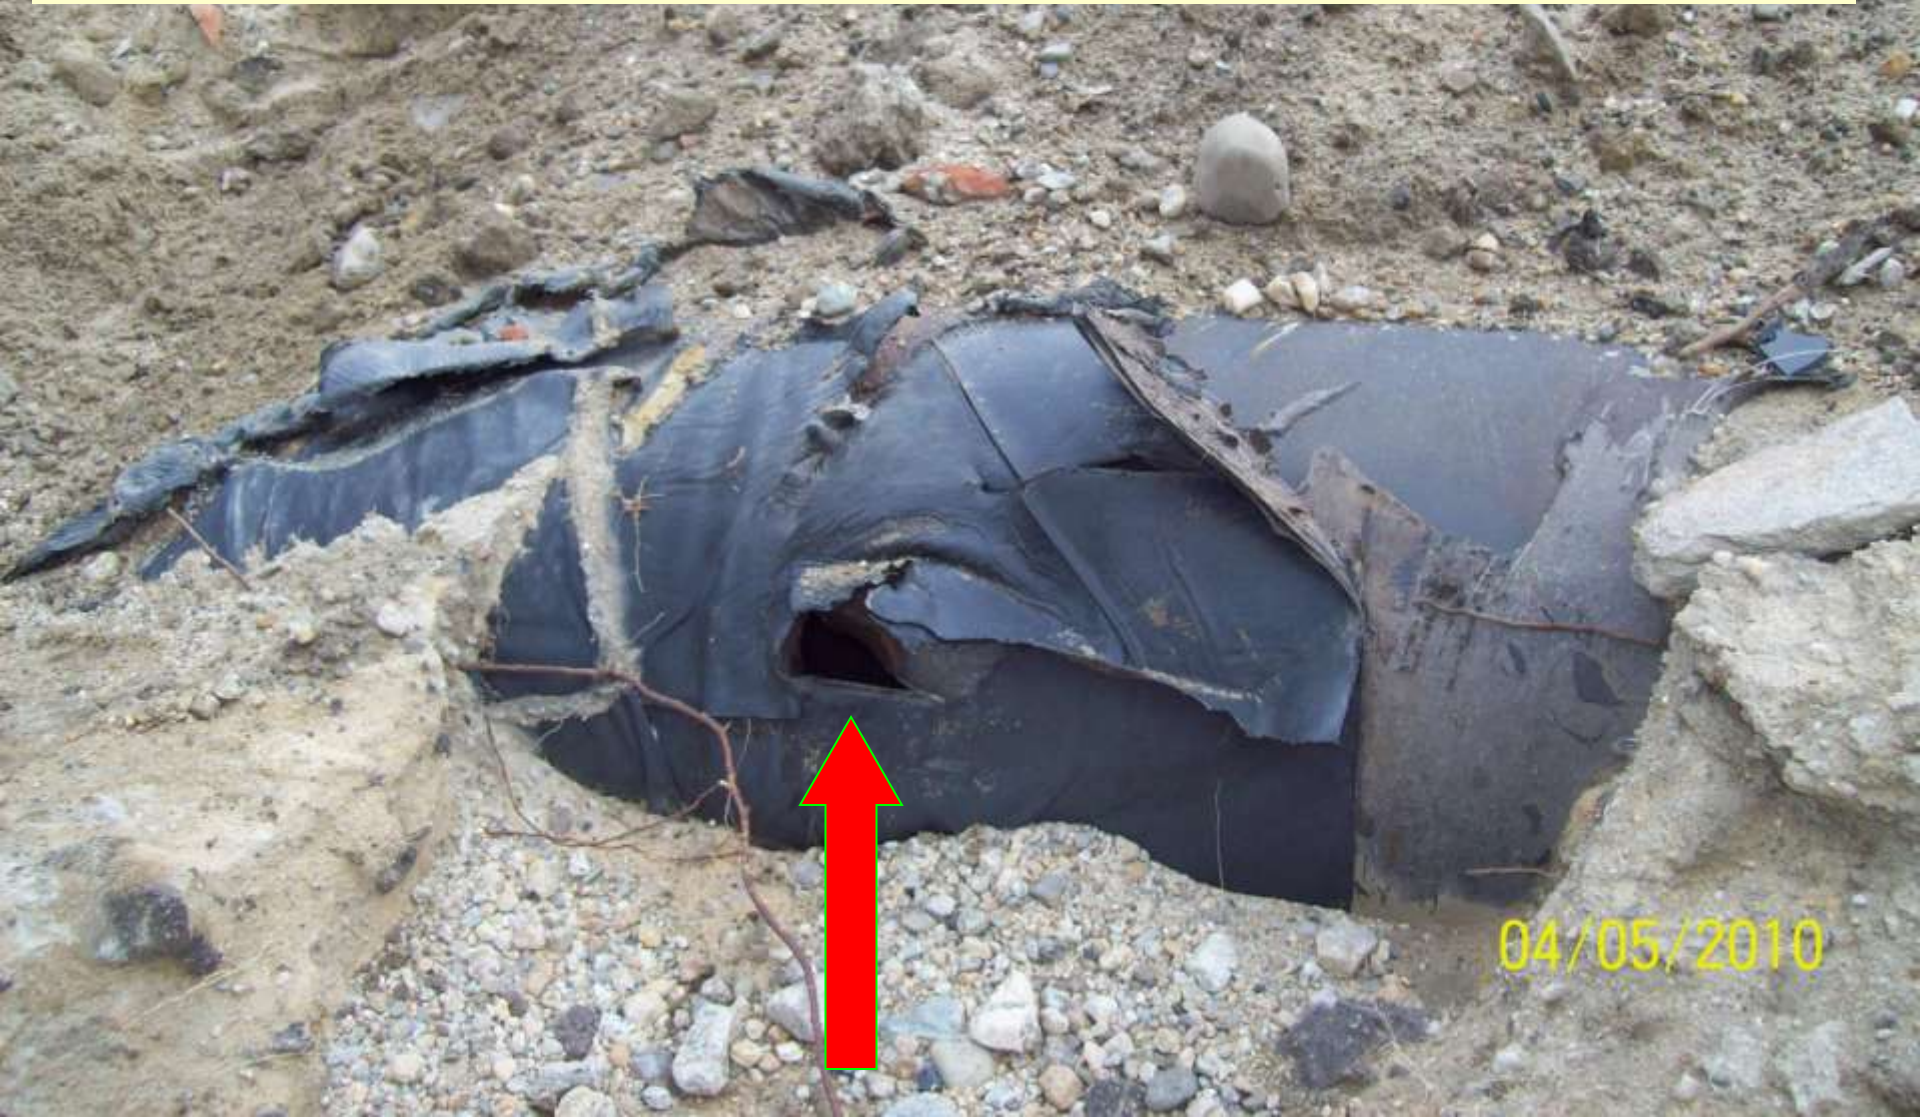
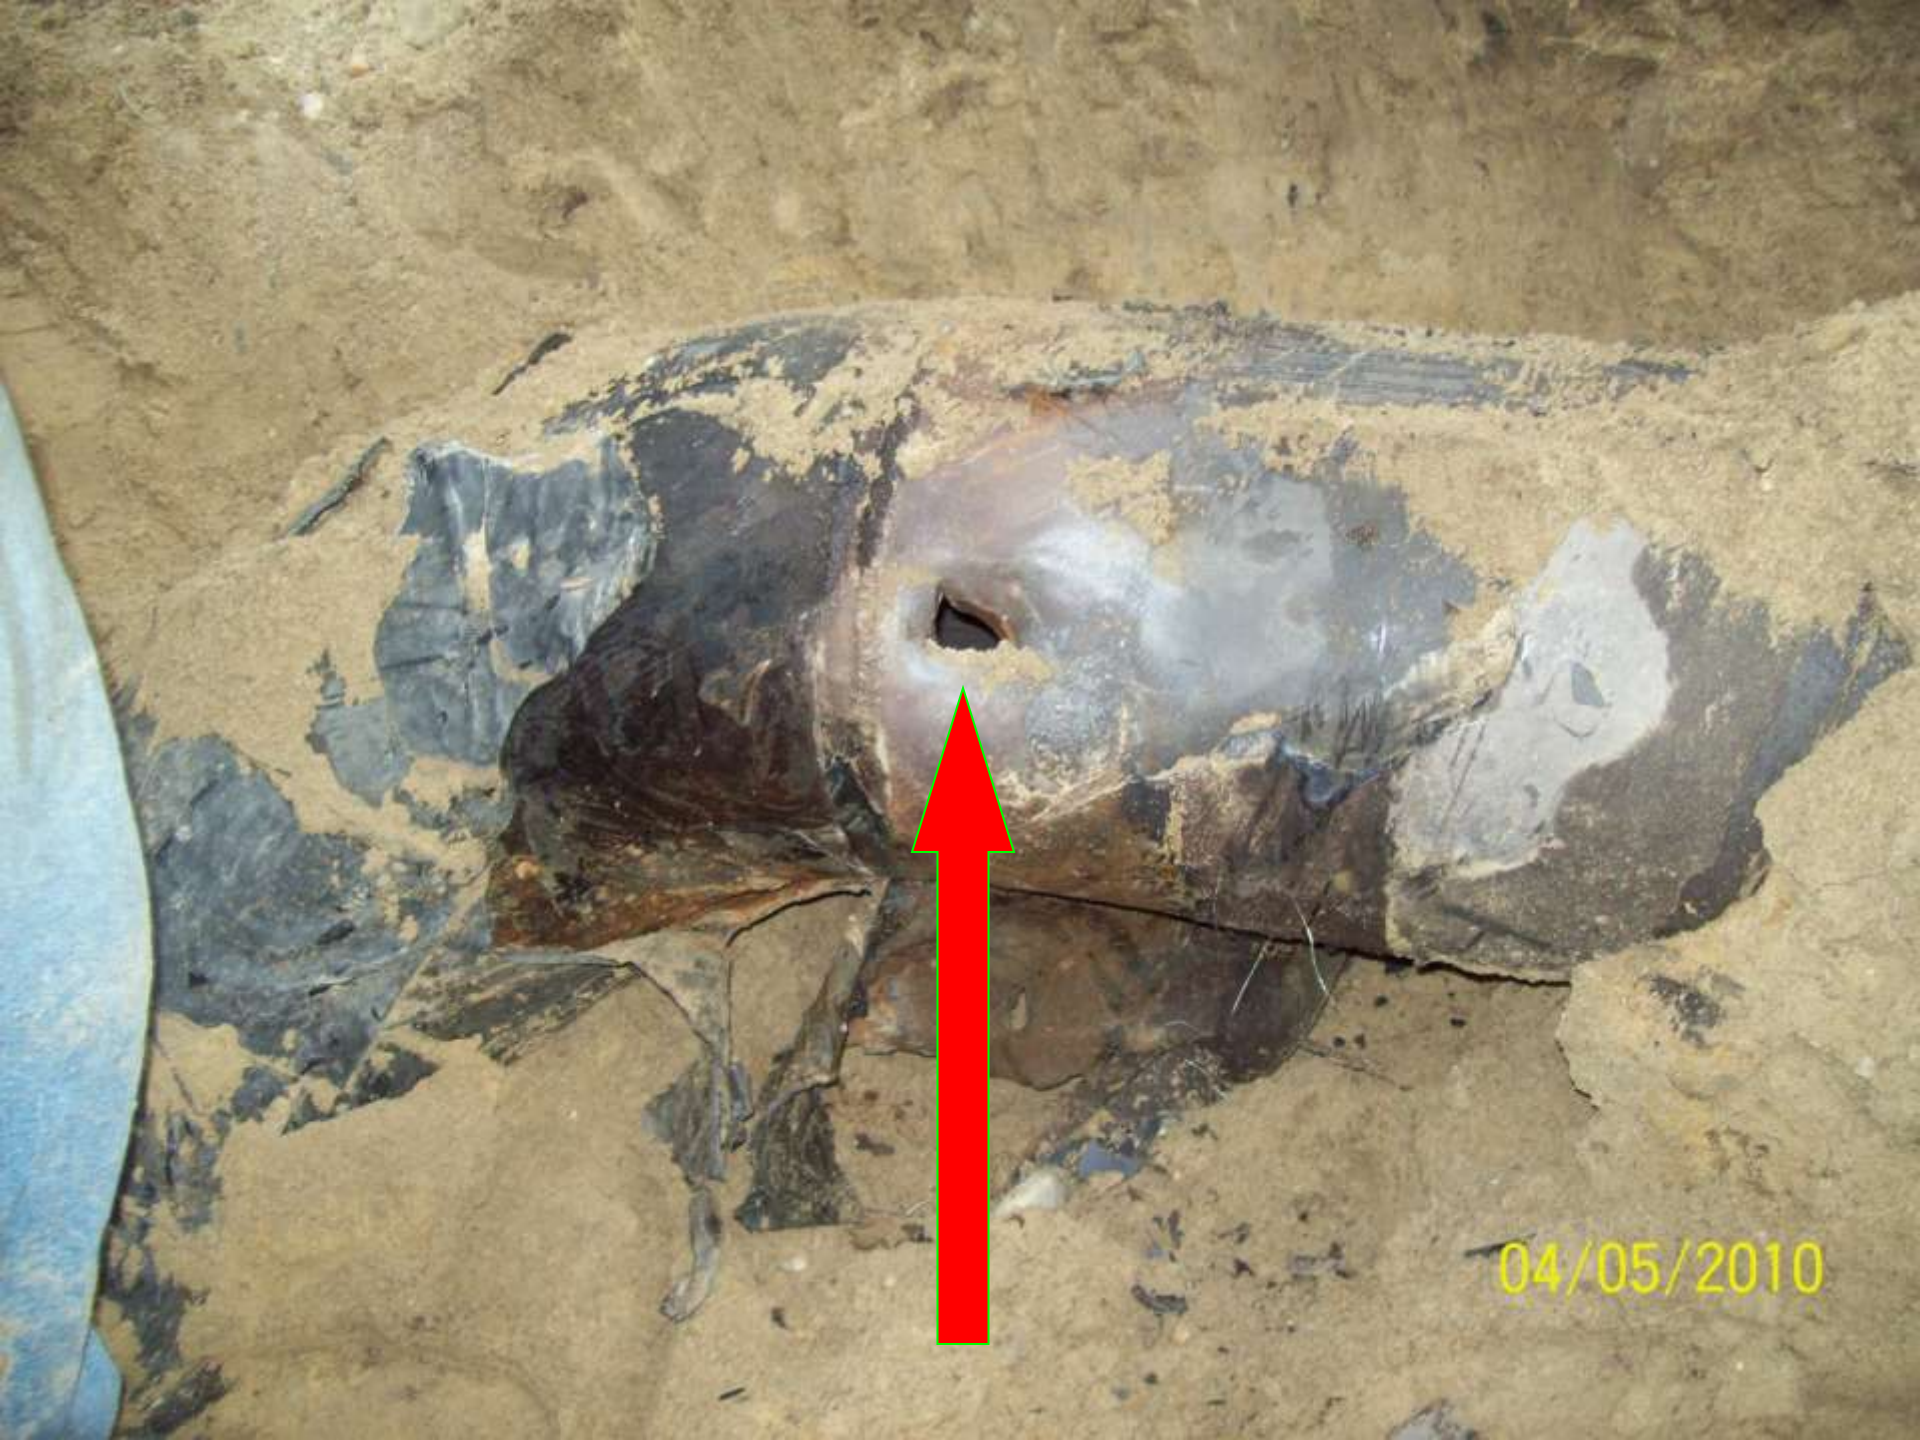
**Until he ruptured a 100 pound gas line feeding a
regulator station...**

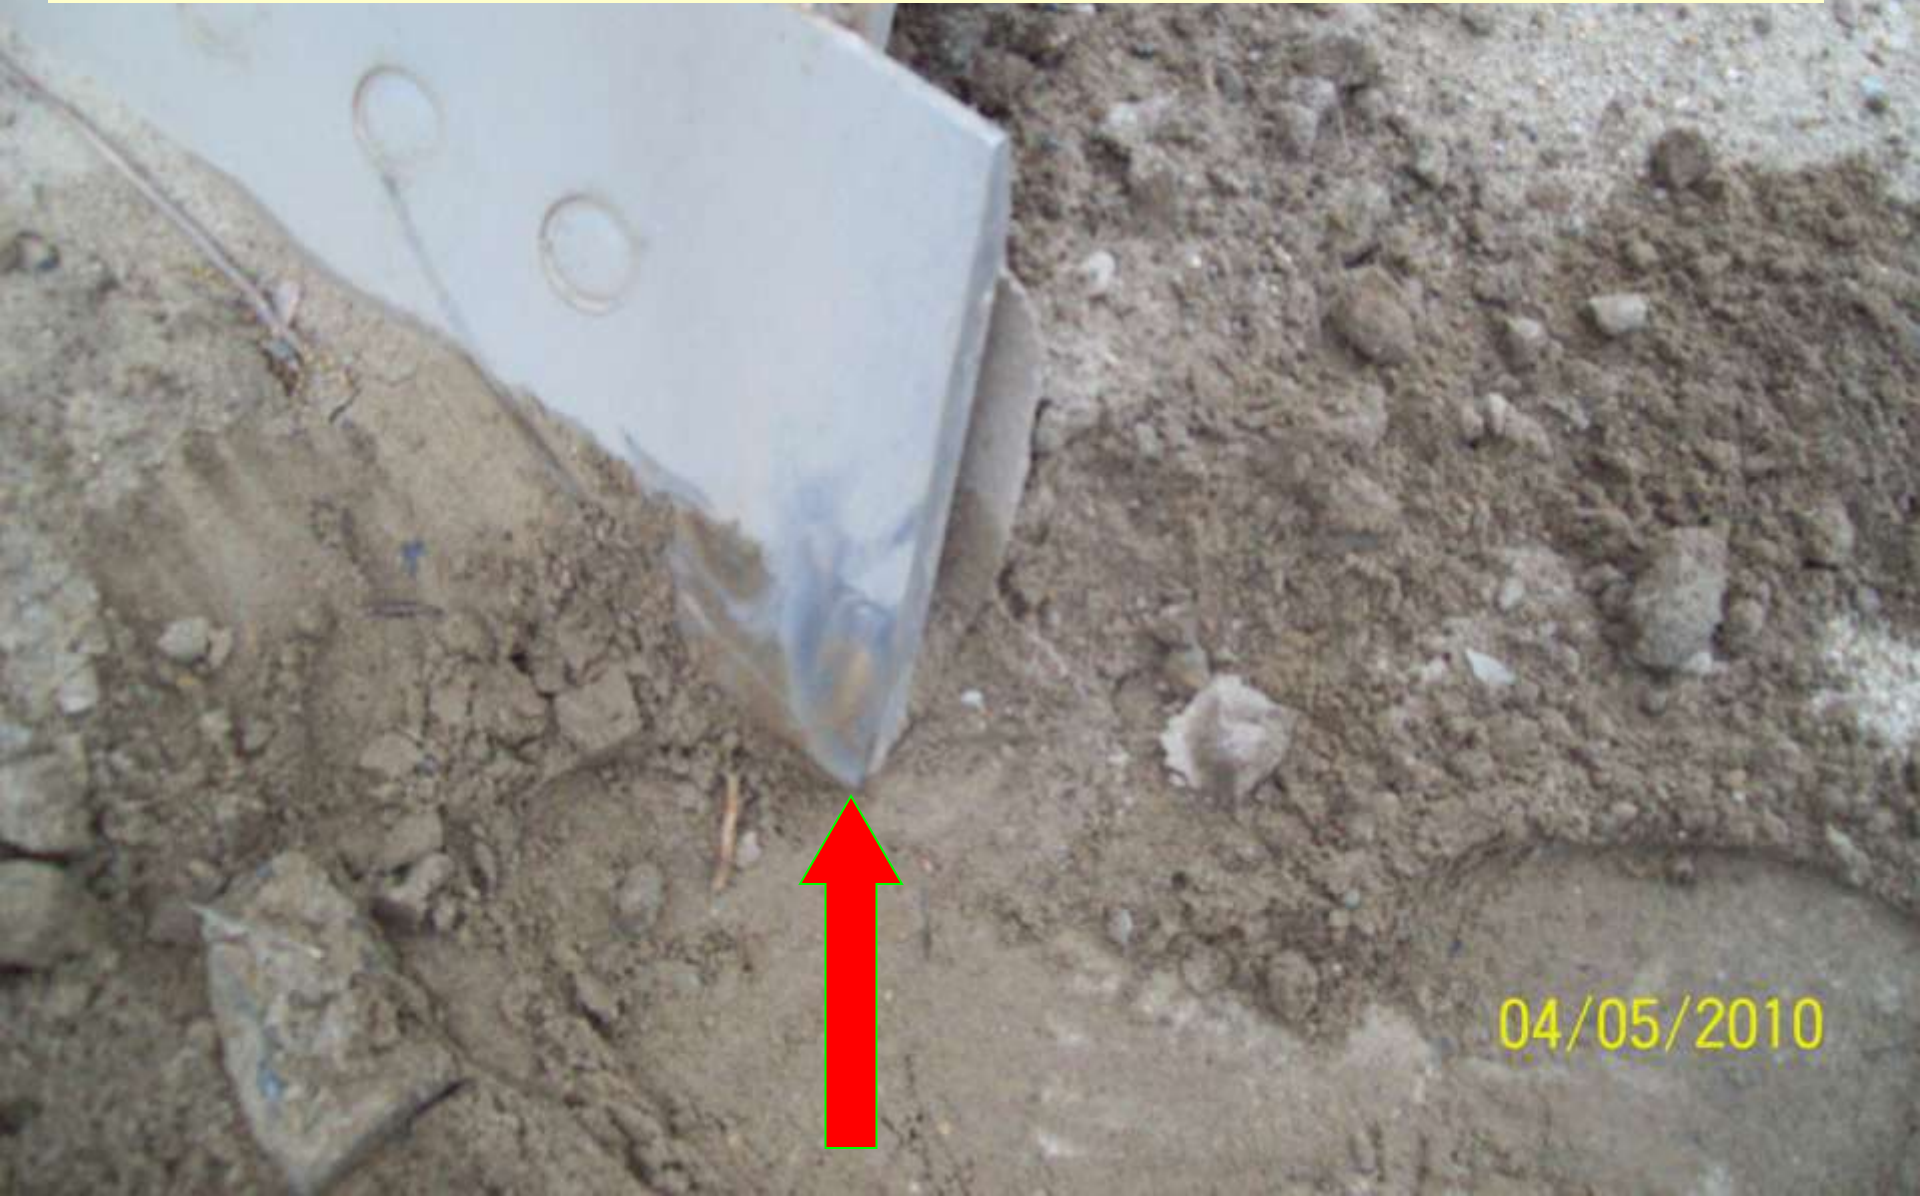
**After the gas stopped blowing the evidence was found
on the tip of the bulldozer blade...**

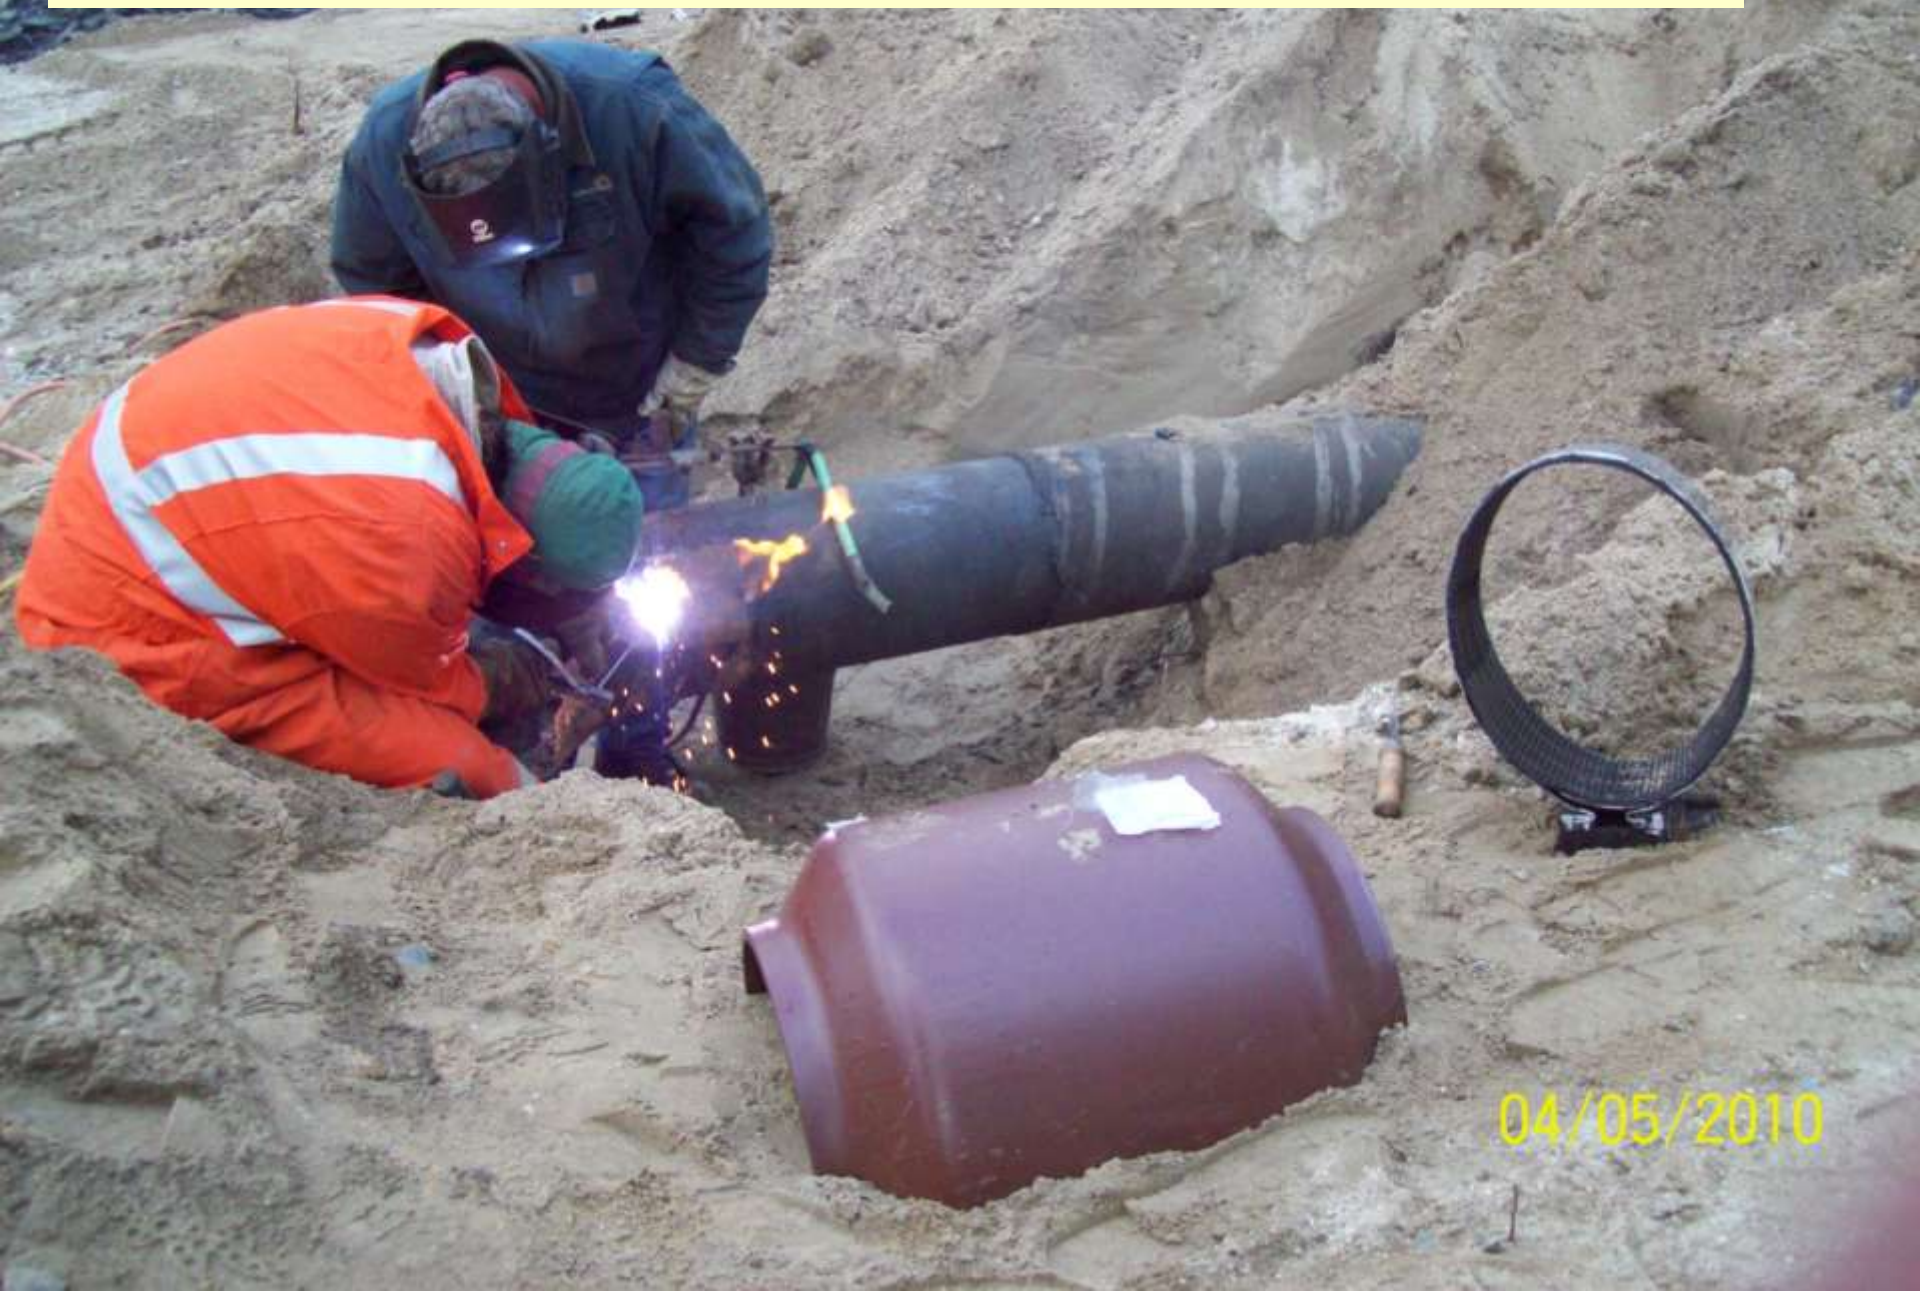
Some of the residual gas ignited during welding...
